## Total Rehabilitation of the Maxilla: a Screw-Retained Prosthesis Using Implants and MUAs by the German Brand XGATE

The key feature of this case is the demonstration of the reliability of XGATE abutments, even during the temporary rehabilitation phase. In this clinical situation, it was not possible to immediately use all four implants to support the prosthesis. However, the temporary structure, retained by only three screws, functioned effectively for the four months required to achieve osseointegration.

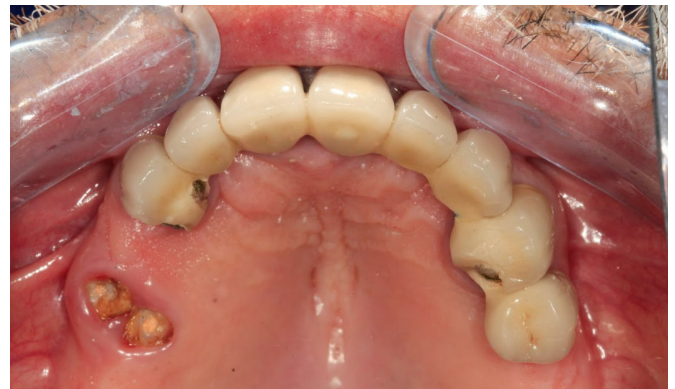
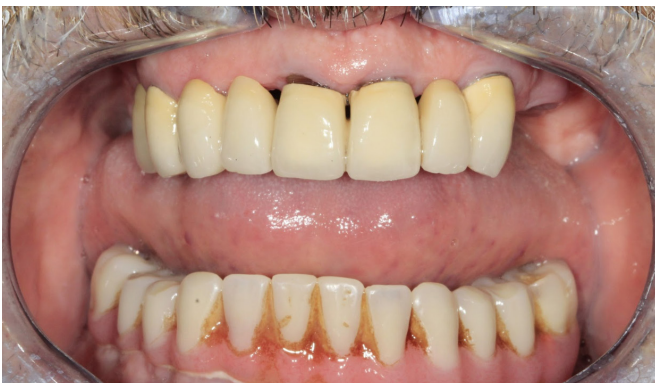
A 73-year-old man in good general health presented to the clinic with a damaged upper overdenture, which was supported by the roots of his natural teeth. The initial condition is clearly visible in the photographs and CBCT scans.

After a clinical and radiographic evaluation, the remaining roots were deemed non-restorable and unsuitable for supporting a new prosthesis. The patient's bar-retained lower denture was assessed as being in good condition and did not require intervention.

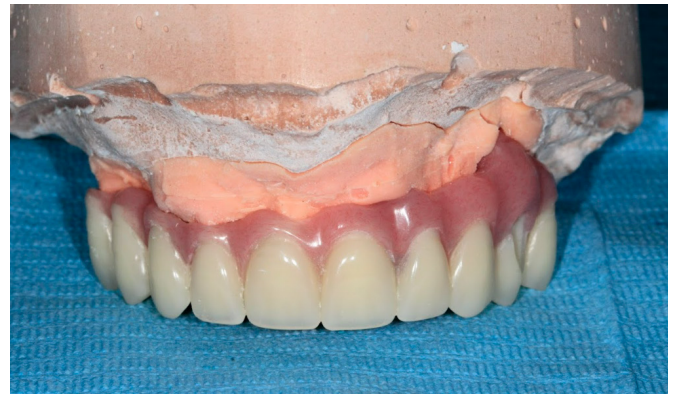
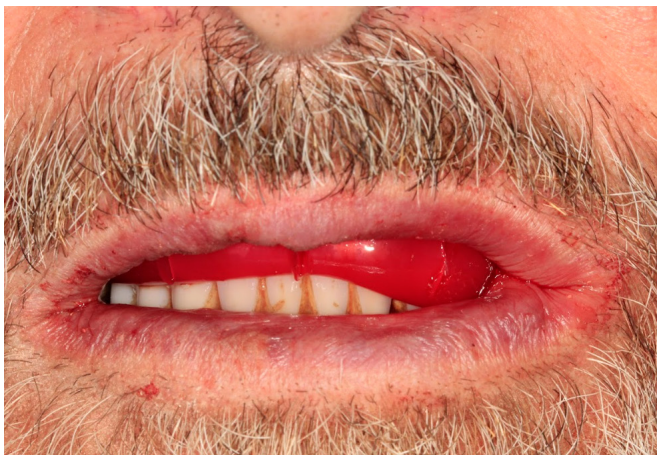
Occlusal registration and the vertical dimension of occlusion were recorded using a wax rim.

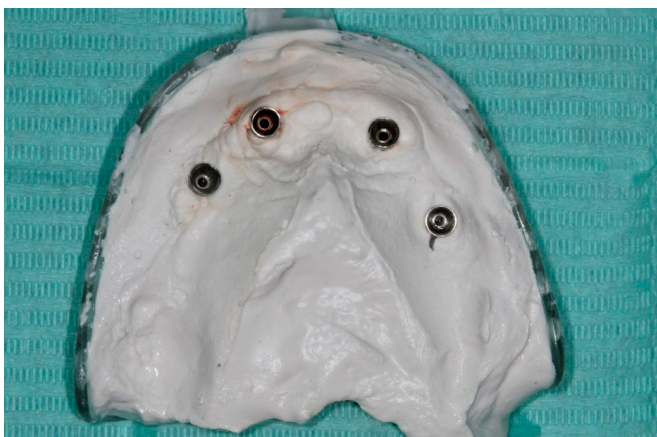
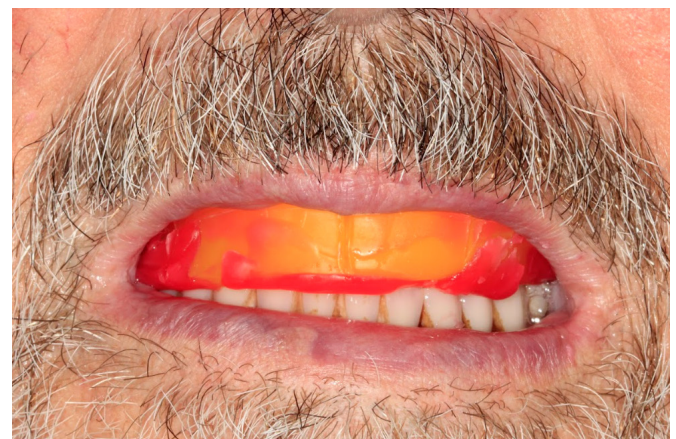
After four months, the temporary prosthesis was removed. The XGATE 30° MUA was successfully placed on the implant in the #25 position with the correct orientation.

A final impression was then taken using MUA-level impression copings to create a **master cast**.

Crucially, the new position of the MUA on the #25 implant no longer presented problems: the screw access channel was correctly oriented relative to the occlusal plane, as originally planned.

Next, the **occlusion was registered** and the **vertical dimension of occlusion** was verified using a wax rim on a screw-retained verification jig.

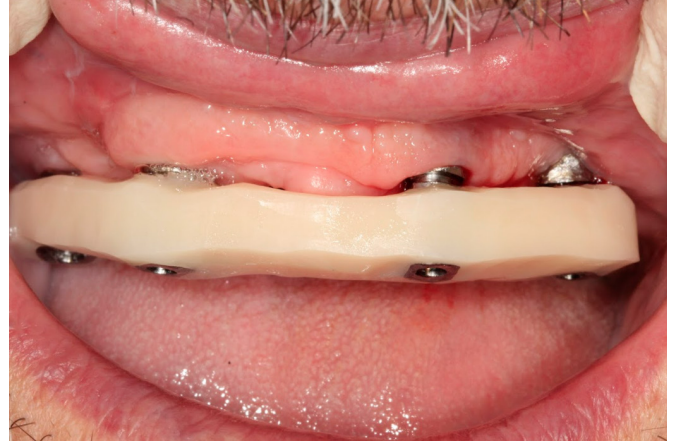
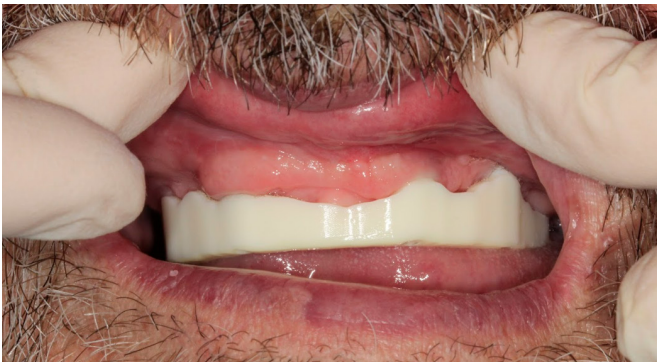
After confirming the vertical dimension of occlusion, a resin verification jig was fabricated to confirm the accuracy of the master cast and to radiographically verify the passive fit of the milled titanium bar.

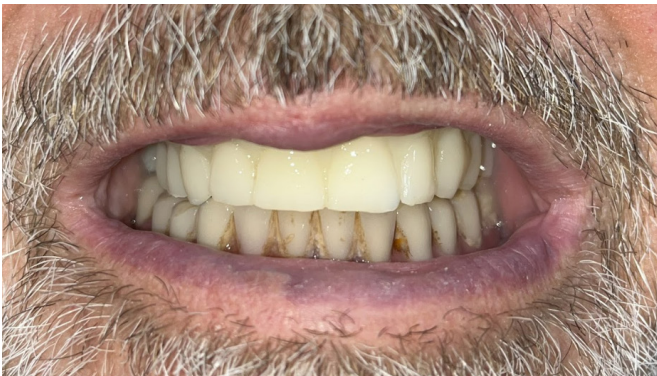
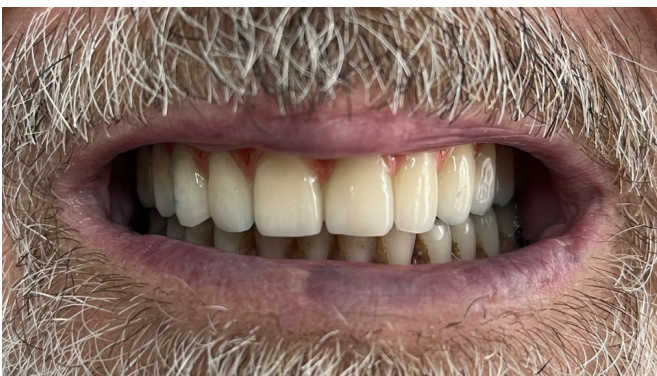
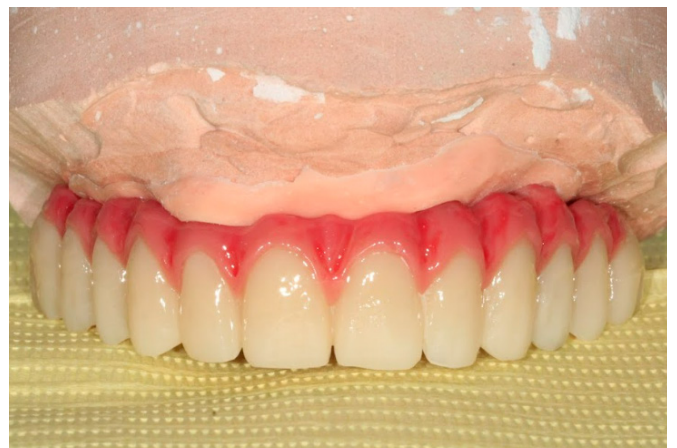
Finally, the occlusion was checked and the **final prosthesis** was delivered. The prosthesis consists of a milled PMMA framework with a pink gingiva fabricated by layering composite resin.

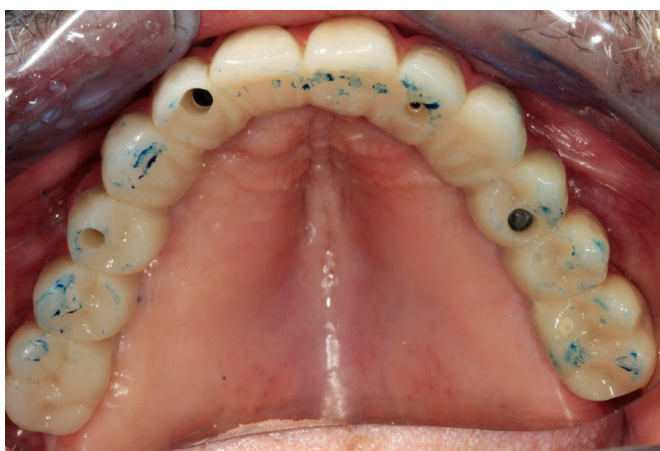
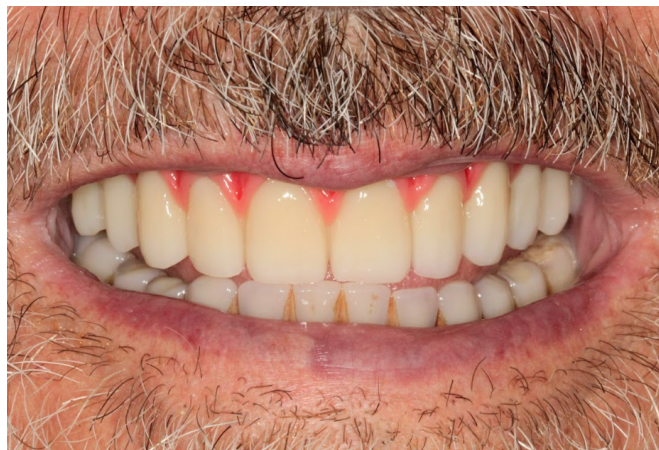
The patient's aesthetics and chewing function were fully restored.
